Prime Inspections Property Inspection Report

Sample Street, Nearby NY, 13833 Inspection prepared for: Jane Sample Agent: Jane Sample -

Inspection Date: 2/28/2009 Time: 11:00 AM Age: 75 years old Size: 2800 SQ Ft Weather: 65* F Nice and Sunny no rain within 24 hrs period

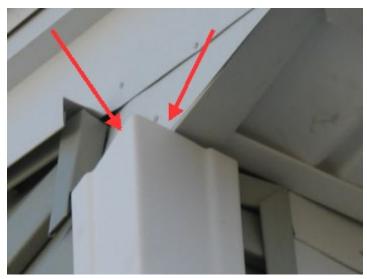
several corner moldings are not properly flashed at the top, allowing for water penetration behind the siding

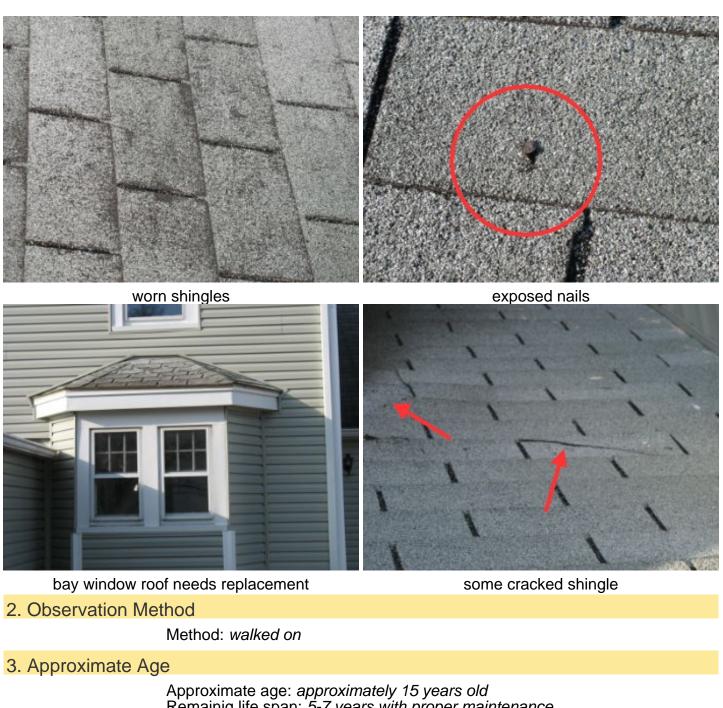
Materials: gable/gable. with several dormers present Materials: asphalt shingles Observations: some cracked shingle. mildly deteriorated material in some areas. exposed nails

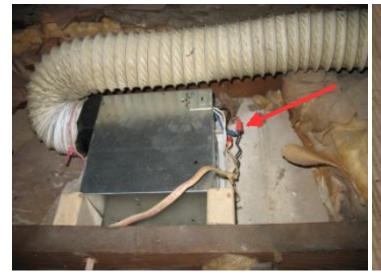
Observations: several splice connections made without J-box. spliced and taped wires. bath fan connection made outside of the housing. recommend qualified individual to make necessary connections. improper electrical installations

bath fan connection made outside of the housing

several splice connections made without J-box

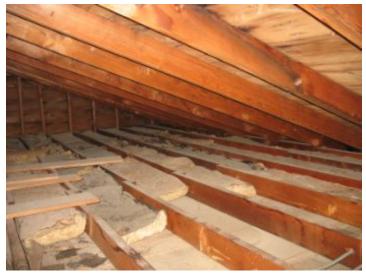
Observations: irregular and insufficient installation, many areas have no insulation present. Attic requires R38-R40 insulating value. Recommend installing 2 layers of R-19 fiberglass bats in a cross pattern style

irregular and insufficient installation, many areas have no insulation present.

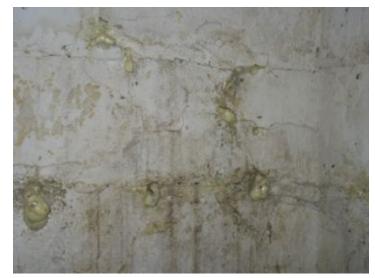
previously repaired small cracks and spalling

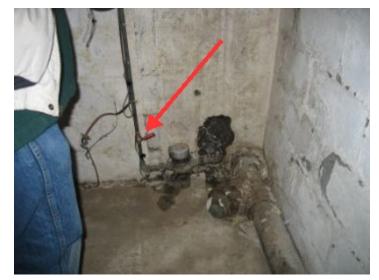
water main shutoff

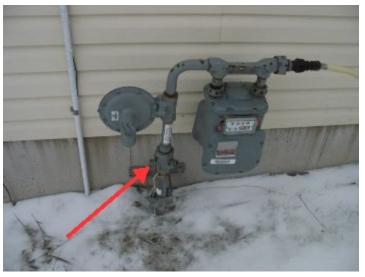
natural gas - main shutoff

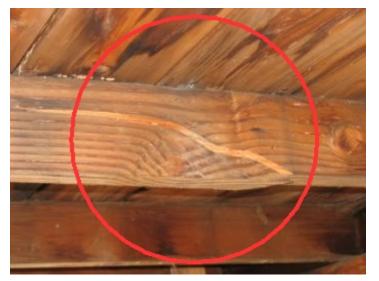
Observations: cracked rafters, probably due to a snow weight on the roof. Recommend repairs by a qualified contractor.

cracked rafters
